<b style="color: red;">Vision Inspection Ltd.		Product Evaluation Report	
China Office Tel: +86 755 29792782 & 29792783		Report No 2333PER130607V1	Page 1 of 13
Fax: +86 755 29792781		e-mail: simon@visioninspection.com.cn

Order Information			
Customer	xxx	Model No	xxxx
Supplier	xxx	Model No	xxxx
Sample Status	1 st (2 pcs)	Description	Convection Heater
Safety Standard	<input type="checkbox"/> CE / <input type="checkbox"/> BS / <input checked="" type="checkbox"/> SAA / <input type="checkbox"/> UL / <input type="checkbox"/> CSA / <input type="checkbox"/> T / <input type="checkbox"/>

Result	
Judgment	<input type="checkbox"/> OK <input checked="" type="checkbox"/> NG <input type="checkbox"/> Re-sample <input type="checkbox"/> Close file <input checked="" type="checkbox"/> Await Customer Decision <input type="checkbox"/> Others <input type="checkbox"/> Require supplier confirmation <input type="checkbox"/> Require follow up action (see below)
Follow up	A – 2, 3; C – 8; E – 1, 2, 3; F – 4, 5, 7.

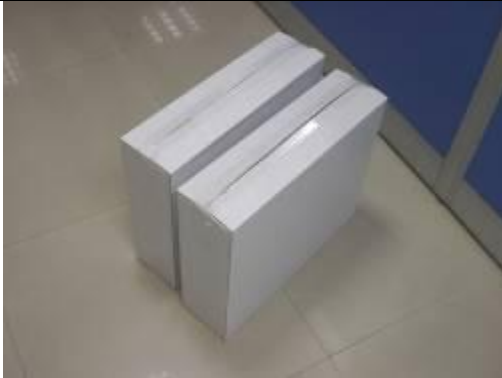
Comments	Ver.	Suggestion	C R	M J	M I
A. Cosmetic check					
1. Packing : Individual (white box) (see photo-1)					
- Logo: Nil - Barcode: Nil - Color & printing: Nil - Label: Nil - Material: Double wall - Size: 495 x 135 x 405mm		Only white box packing. Clarify with customer the individual packing method. Clarify with customer that color & printing requirement, logo, barcode No. and whether need the "WEEE" mark for individual packing box.

Photo-1 White box packing for main unit

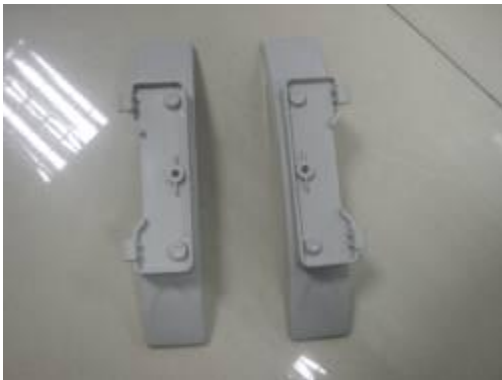
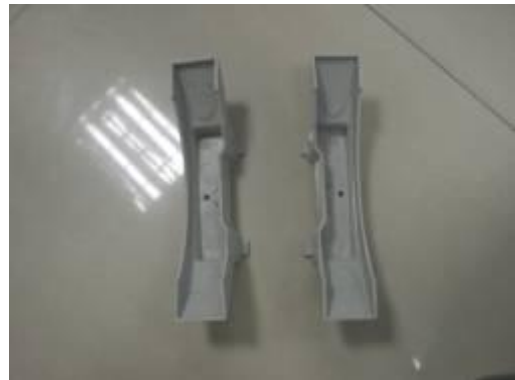
- Base stand (see photo-3,4)					
• Without poly bag for base stand packing.	NG	Need to add poly bag for base stand packing			√
• Color: Grey.					
- Poly bag for fixing kit.

Photo-3 Base stand

Photo-4 Base stand

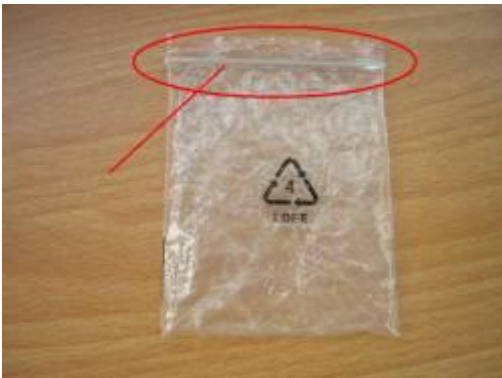
• Size: 105x 80mm.					
• Use the poly bag with pressed-inside opening which may easily open during transportation and make accessories in the bag dropping out. (see photo-5)	NG	Need to improve the sealing of poly bag. Suggest using shrink wrap to seal the poly bag.			√

Photo-5 Use the poly bag with pressed-inside opening which may easily open during transportation and make accessories in the bag dropping out.

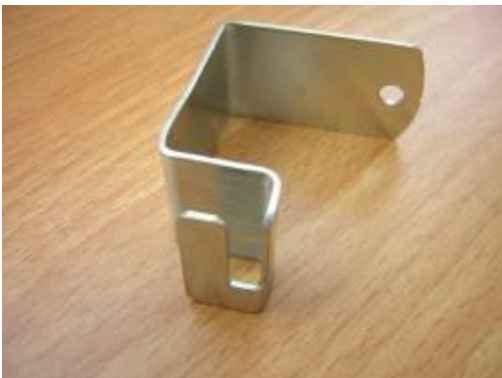
Photo-6 Mounting plate for rear unit: 2pcs

- Mounting plate for rear unit: 2pcs (see photo-6)					
- Mounting plate for bottom unit: 1pc (see photo -7)					
- Concrete anchor: 3pcs (see photo-8)

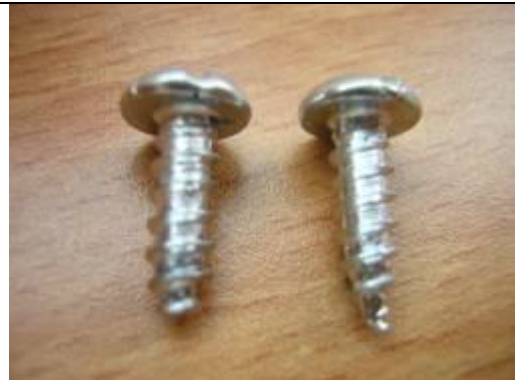
Photo-9 Wood screw: 3pcs

- Wood screw: 3pcs (see photo- 9)					
- Phillip screw: 2pcs (see photo-10)					
3. Unit					
- Labeling					
• Rating label on rear of unit. (see photo-11)

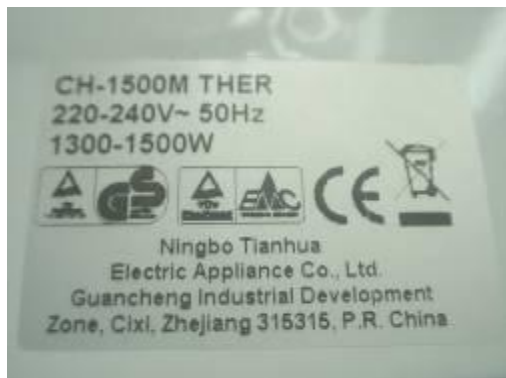
Photo-11 Rating label on rear of unit.

- Marking:					
• With CAUTION text "DO NOT COVER" engraving on front of unit. (see photo-12)		Clarify with customer whether need to add approval No. and C-Tick mark on rating label.

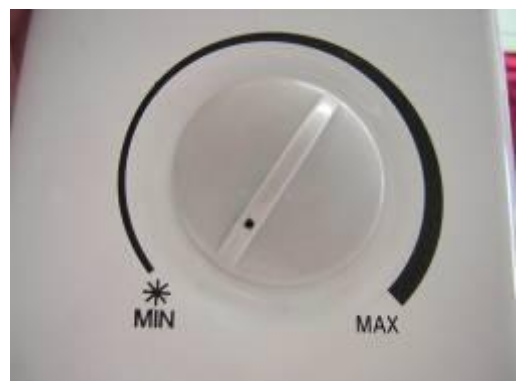
- With rated voltage, rated power input, rated frequency, model No., TUV, GS, EMC, CE mark on rating label.
- Power “O” and “ I ” mark on panel. (see photo-13)

Photo-13 Power "0" and "I" mark on panel.

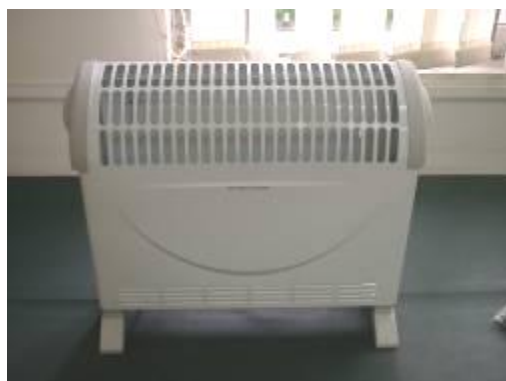
- T.STAT “MIN” and “MAX” on panel. (see photo-14)
- Power plug
- Color: black (without protective plastic on plug pin)
- Marking: (see critical part list)

Photo-14 T.STAT "MIN" and "MAX" on panel.

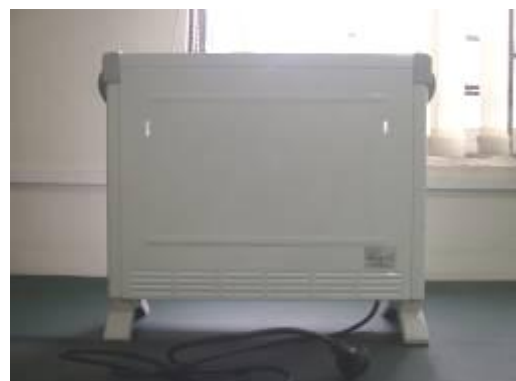
Photo-15 Outer shell: front

- Outer shell: white (see photo-15~20)
- Handle: gray (see photo-21,22)
- Power switch: black (with red indication light)
- Thermostat switch: gray (see photo-23)

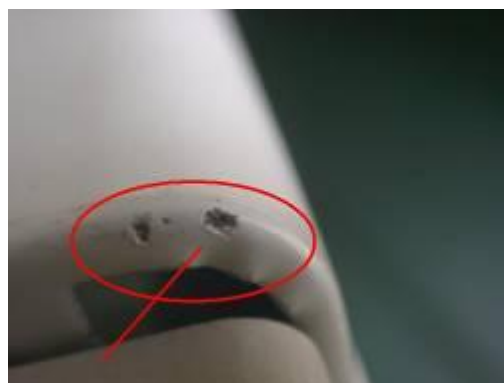
- Screws:
- Philip screw: 2pcs (use to fix the handle)
- Anti-temper screw: 4pcs (use to fix the outer shell)
- Unit outer shell appearance check:
- Coat on bottom of unit loose out. (1pc) (see photo-24)

Photo-24 Coat on bottom of unit loose out.

NG	Need to add protective plastic on plug pin.	√
	Clarify with customer for the cord length specification.	
	Clarify with customer for the logo requirement.	
	Clarify with customer color of product.	
NG	Need to improve the coat spraying on outer shell.	√
NG	Need to improve the coat spraying on outer shell.	√
NG	Need to improve the coat spraying on outer shell.	√
NG	Need to improve the coat spraying.	√

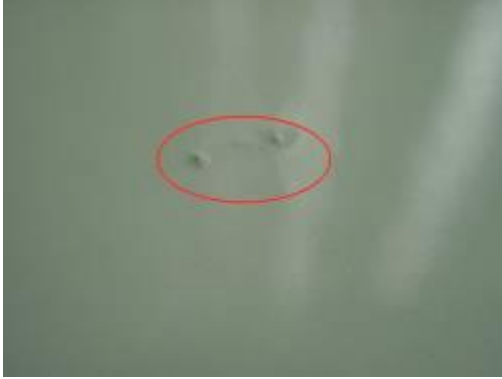
- Coat on outer shell surface bulgy. (1pc) (see photo-25)
- Poor painting of inner bracket buckle position. (2pcs) (see photo-26, 27)
- Poor painting on rear inner buckle position. (can be seen clearly form outer produce) (see photo-28, 29)

Photo-25 Coat on outer shell surface bulgy.

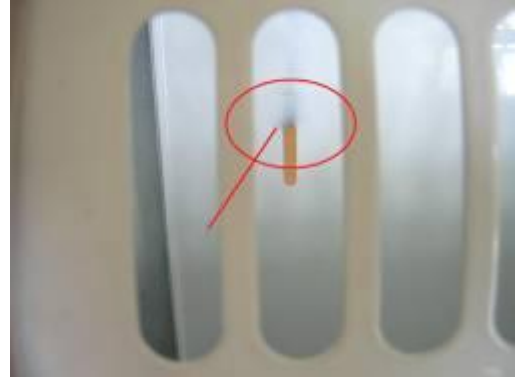
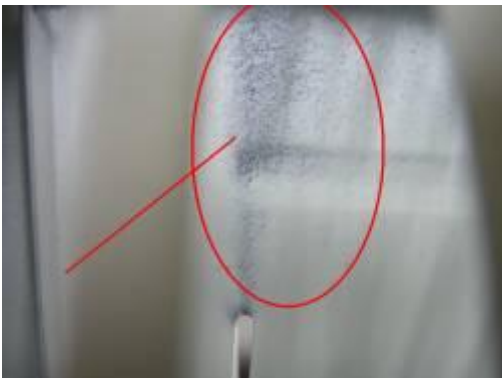
Photo-26 Poor painting of inner bracket buckle position.-1

Photo-27 Poor painting of inner bracket buckle position.-2

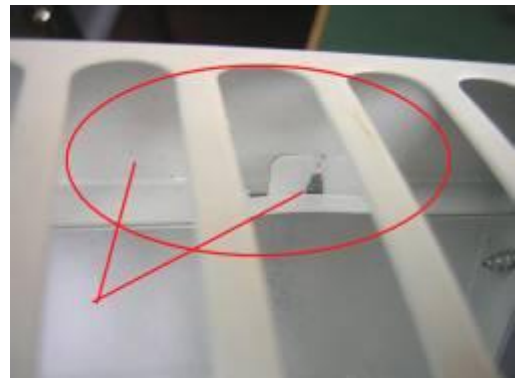
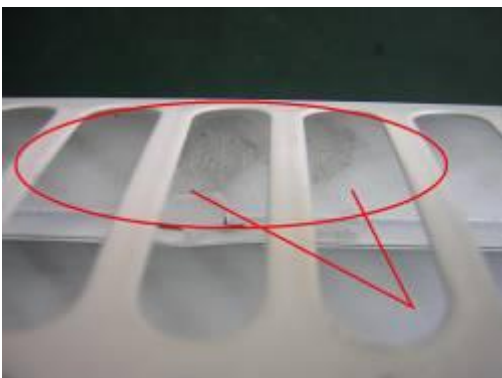
Photo-28 Poor painting on rear inner buckle position. (can be seen clearly form outer produce)-1

Photo-29 Poor painting on rear inner buckle position. (can be seen clearly form outer produce)-2

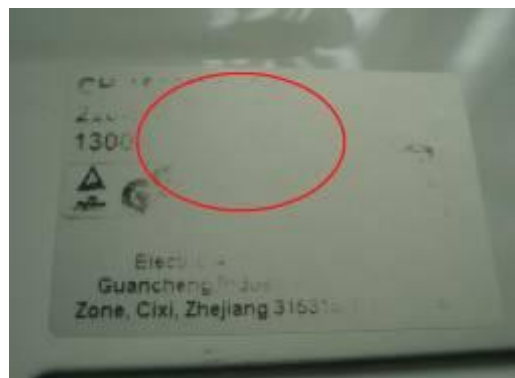
8. Rubbing test on rated label:				
- Use alcohol to do rubbing test on surface of rated label with force of 300g for 15 times, letter on the label was erased. (see photo-30)	NG	Need to improve the material of rating label. Suggest using UV material for the rating label.	√

Photo-30 Use alcohol to do rubbing test on surface of rated label with force of 300g for 15 times, letter on the label was erased.

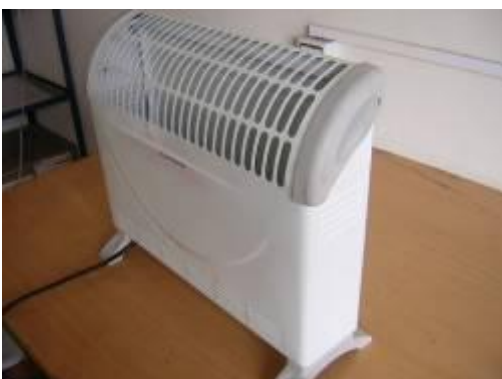
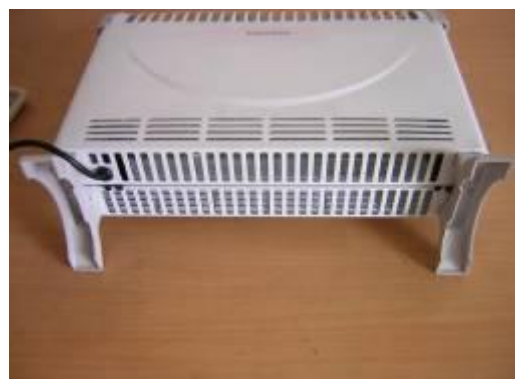
9. Base stand assembly test:				
- Use screw to fix the base stand.	OK			
- Stable degree test on base stand of unit. (see photo-31,32)	OK			
10. Mounting plate assembly test

Photo-31 Stable degree test on base stand of unit. -1

Photo-32 Stable degree test on base stand of unit. -2

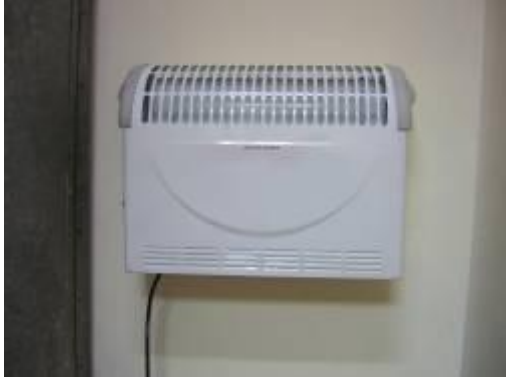
- Use 8 mm drill to make hole in the wall and drive in the concrete anchor, and then use the wood screw to fix the bracket and put the main unit on the bracket. (see photo-33)	OK

Photo-33 Use 6mm drill to make hole in the wall and drive in the concrete anchor, and then use the wood screw to fix the bracket and put the main unit on the bracket.

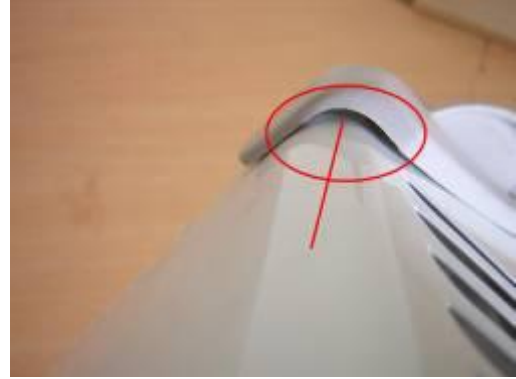
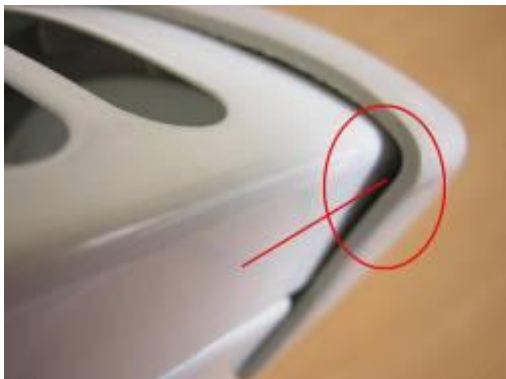
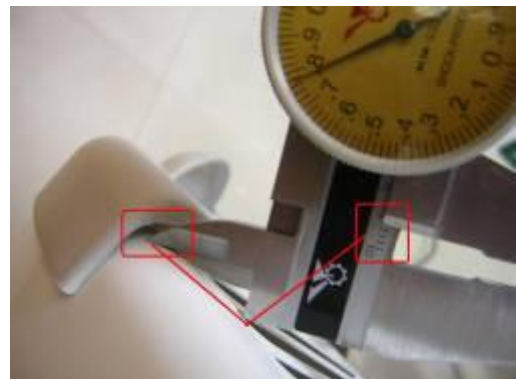
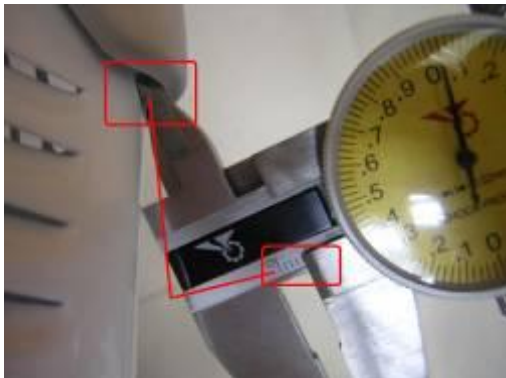
- Handle of unit assembly construction check	OK			
• Gap about 3.7- 4.0mm between handle and unit outer shell. (see photo-34~37)	NG	Need to improve handle construction		√

Photo-34 Handle of unit assembly construction check: Gap about 3.7- 4.0mm between handle and unit outer shell. -1

Photo-35 Handle of unit assembly construction check: Gap about 3.7- 4.0mm between handle and unit outer shell.-2

Photo-36 Handle of unit assembly construction check: Gap about 3.7- 4.0mm between handle and unit outer shell. -3

Photo-37 Handle of unit assembly construction check: Gap about 3.7- 4.0mm between handle and unit outer shell. -4

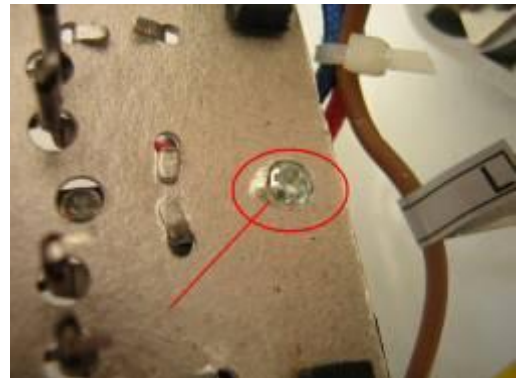
• Screw gets into the mica plate, and cause the mica plate loose out. (see photo-38)	NG	Need to improve. Suggest changing for the screw with cap or adding the washer under the screw.		√

Photo-38 Screw gets into the mica plate, and cause the mica plate loose out.

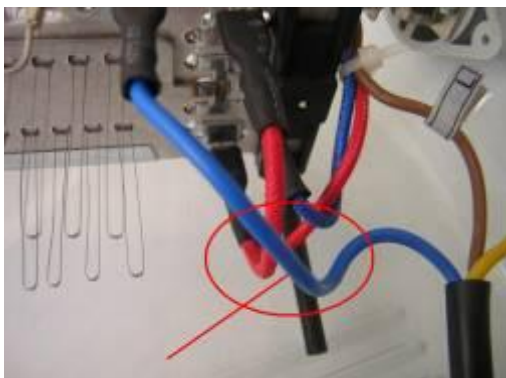
• "L" and "N" wires of power cord are too near to the thermal link. (Reference photo-39)	NG	Need to improve. Suggest adding a protective bushing for the "L" and "N" wires.		√

- Label fixing on inner of power cord check:				
• Label on "N" wire of power cord missing. (see photo-39)	NG	Need to add "N" label on N wire of power cord.		√

Photo-39 Label on "N" wire of power cord missing.

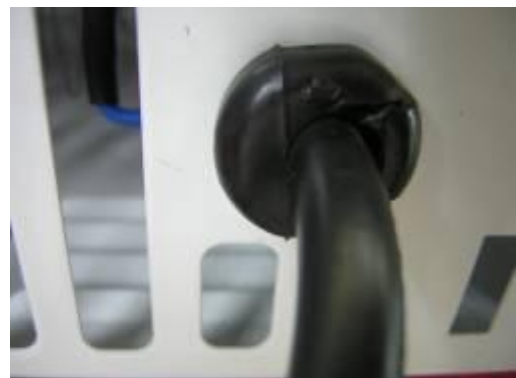
1. Power cord fixing status check:				
- Power cord fixing on outer shell status check. (see photo-40)	OK			
- Power cord and cable gripper fixing status check. (see photo-41)	OK

Photo-40 Power cord fixing on outer shell status check.

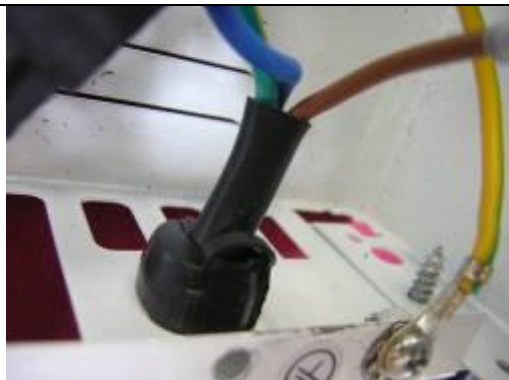
Photo-41 Power cord and cable gripper fixing status check.

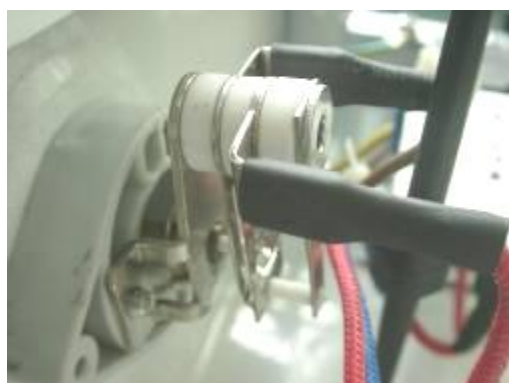
- Inner wiring fixing on inner body status. (see photo-42) 3. Connection terminal fixing on heating element, power switch and thermostat check. (see photo-43~46) 4. Heating element fixing status - Distance between heating elements not even, distance between some of the heating elements is only 0.2-0.8mm. (see photo-47, 48) - Terminal of heating element fixing status check. (see photo-49, 50) 5. Label of power cord fixing status check. - Poor adhesion of label on power cord "L" wire, and it's easy to loose out. (see photo-51) 6. Earth label fixing status check. (see photo-52) 7. Connection wire and terminal fixing status check: - Found that connection wire can not fix in the terminal completely. (see photo-53)	OK OK NG OK NG OK NG	Need To improve. The distance between the heating element should $\geq 4\text{mm}$. Need to improve the adhesive workmanship of label. Need to improve the connecting workmanship.	✓ ✓ ✓

Photo-42 Inner wiring fixing on inner body status.

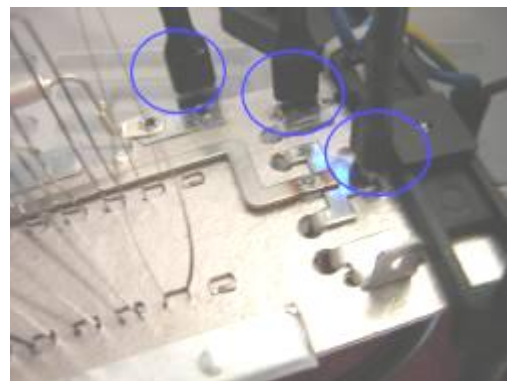
Photo-45 Connection terminal fixing on heating element check.

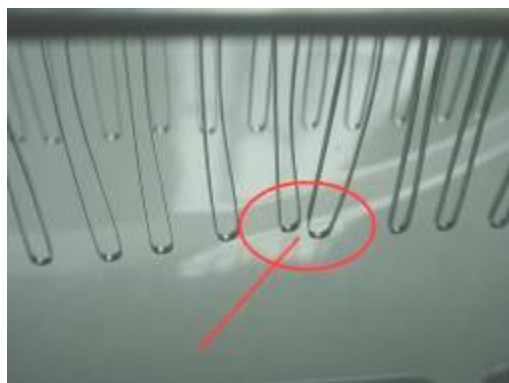
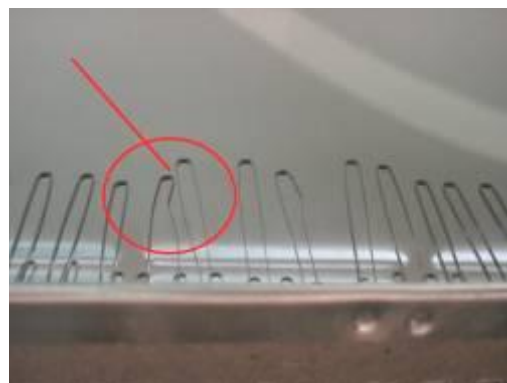
- a. Heating element fixing status: Distance between heating elements not even, distance between some of the heating elements is only 0.2-0.8mm.
- b. Label of power cord fixing status check: Poor adhesion of label on power cord "L" wire, and it's easy to loose out.
- c. Connection wire and terminal fixing status check: Found that connection wire can not fix in the terminal completely.

Photo-47 Heating element fixing status: Distance between heating elements not even, distance between some of the heating elements is only 0.8mm.

Photo-48 Heating element fixing status: Distance between heating elements not even, distance between some of the heating elements is only 0.2mm.

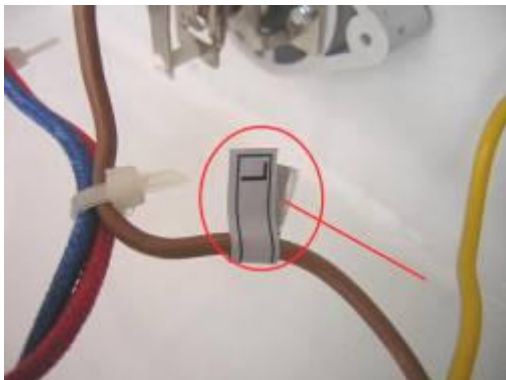
Photo-51 Poor adhesion of label on power cord "L" wire, and it's easy to loose out.

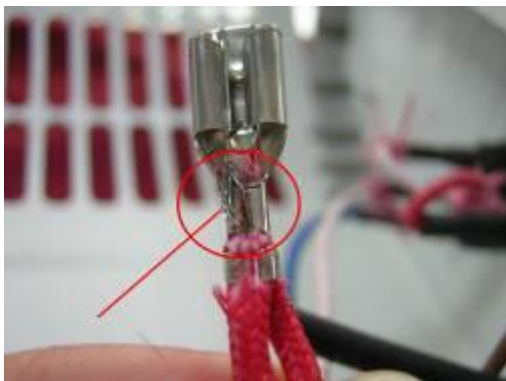
Photo-53 Found that connection wire can not fix in the terminal completely.
